2020 WHITE PAPER

THE TRUTH ABOUT WATER RESISTANT GLAZING

Ray Crawford
President, Crawford-Tracey Corporation

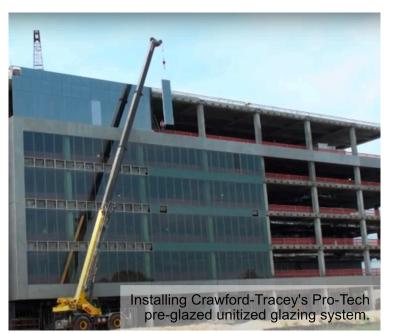
The glazing system design, installation method and the application and use of sealants play a significant role in keeping a structure dry during and after a weather event. Window system joinery is a critical area that can be problematic, particularly if there are exposed framing joints, improper joint construction, or incorrect application of joinery sealants. Perimeter sealant perforation or failure also contributes to unimpeded water intrusion. Older mindsets have been to try and incorporate dual

beads of sealants on the systems to try and mitigate the continuous failures of poorly designed systems. The #1 problem with that approach is that instead of improving the design, the second bead acts as a "band aid" and can be a formula for bigger problems. The development of a leak and the failure of the exterior sealant bead will result in delayed or masked indication of the failure. The second bead/sealant can divert water concealed cavities within the surrounding materials where it can collect and get trapped. Over time the wet conditions can likely develop mold and sick building issues. Not a preferred or ideal approach.

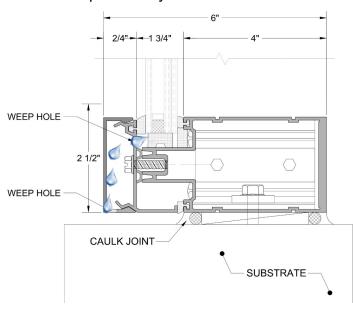
Pressure-Equalized Systems

Pressure-equalized systems rely on pressure equalization, gaskets, seals, and weeps to control the infiltration of water. The interior interface of the glass and the frame establishes the difference between the wet side and dry side. When the system is exposed to wind driven rain and a pressure difference, water may penetrate past the first gasket into the drained cavity.

Unlike the older designs of the conventional pressure-equalized and/or rain screen systems, the face-seal barrier wall performs leaps and bounds above the rest in terms of water resistance and endurance. In comparison, the pressure-equalized system utilizes exposed joinery, exposed anchors, captured glazing, gaskets, weeps, and sill pans that must work together in "perfect harmony" to preclude water intrusion. The 4-sided structurally glazed system, particularly the face-sealed barrier wall concept has its framing components entirely on the dry side of the system. The glass and silicone sealant at the exterior face serve as the principal drainage plane – no weeps, joints, or pressure bars, just silicone and glass. Though the face-sealed barrier wall concept is not as prevalent or age-old as the pressure-equalized model, it serves to be simpler, durable, and more easily maintained for a much longer period.

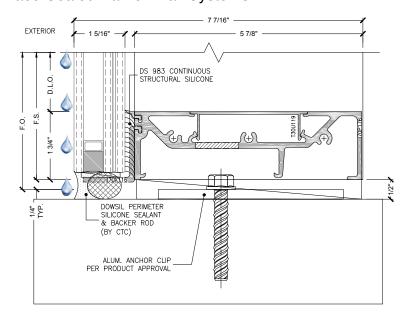
Face-Sealed Barrier Wall Systems

The face-sealed barrier system's principal drainage plane consists of glass and silicone and does not allow water past the exterior plane of the system.

A humorous fact is that typically when the rain screen or pressure-equalized systems typically fail, the common approach is to then try to repair the system by using applied sealants in an attempt to convert it to a face-seal barrier wall system. However, due to the immense number of joints and exposed union of materials, it is very difficult.

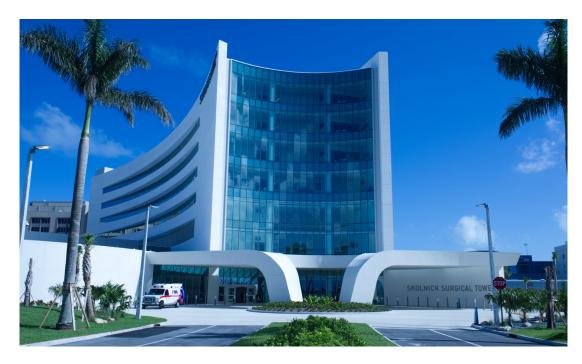
TYPICAL FAILURES

Recent hurricanes have proven that most of the typical failures of the conventional pressure-equalized system design is its exposed metal joinery. During extreme wind events, the continued cyclic movement of the framing components dislodges the seals at the assembly joints. Unfortunately, the joints are prepared and sealed during manufacturing and installation, and do not typically have access or reasonable means for repair or remediation of those failed conditions.
